# **Hurricane Harvey-Texas**

**Situation Report #3**

**Date:** 9/1/2017

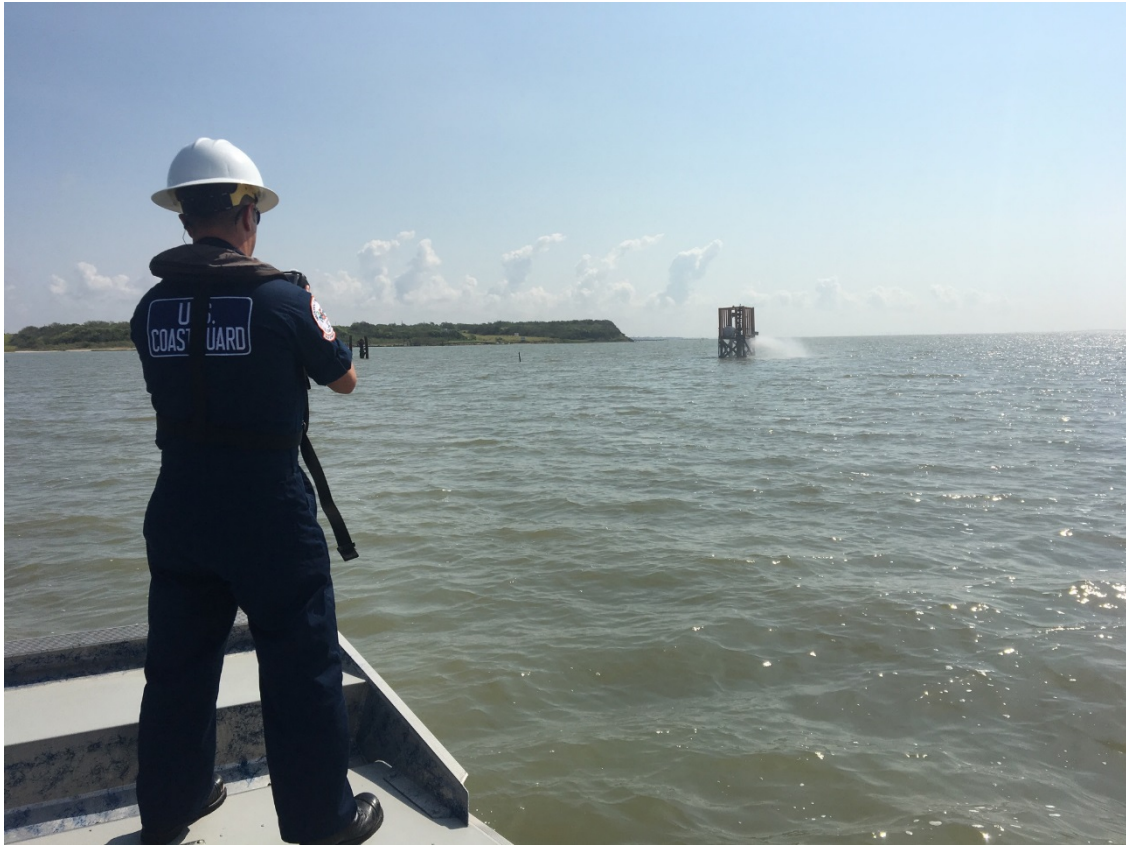
Photo 1. Well Head in Nueces Bay

An overflight revealed a well blow-out suspected to be gas and oil in Nueces Bay, E. White Point. An assessment team was diverted to perform an assessment at this location and determined the well to be for natural gas well. The owner of the well head was contacted and determined that the well was discharging salt water.

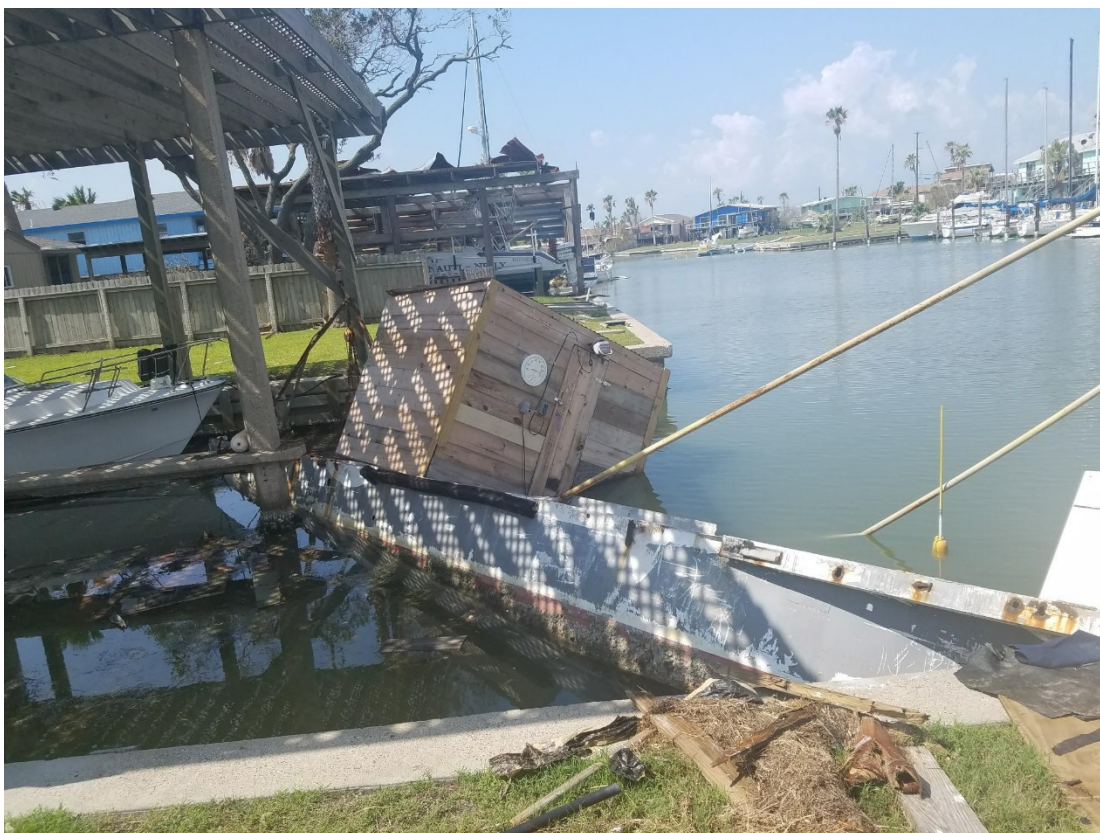
Photo 2. M/V Roma

In Ingleside by the Bay a 40ft by 12ft barge named M/V ROMA was reported to have drifted into a concrete wall and the Port Side was partially submerged. The owner was contacted. Teams were dispatched to perform a hazard assessment and complete an NDOW sheet. No discharges were observed and the owner is responding.
